Methyl Bromide Field Operation Guidance (MB FOG) Report

April 13, 2015

Based on an Operational Decontamination Assessment of Methyl Bromide
Fumigant or *Bacillus anthracis* Sterne

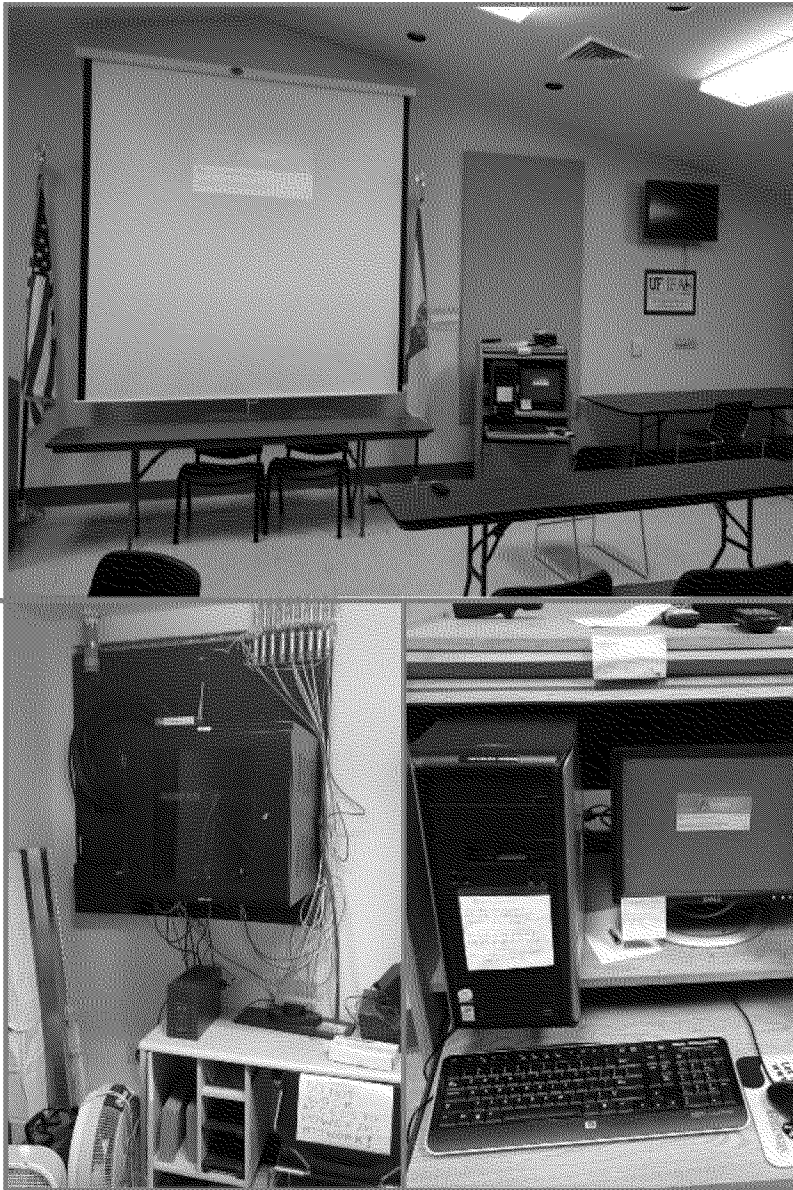
Figure 3. The Electronics that Remained in the House during Fumigation

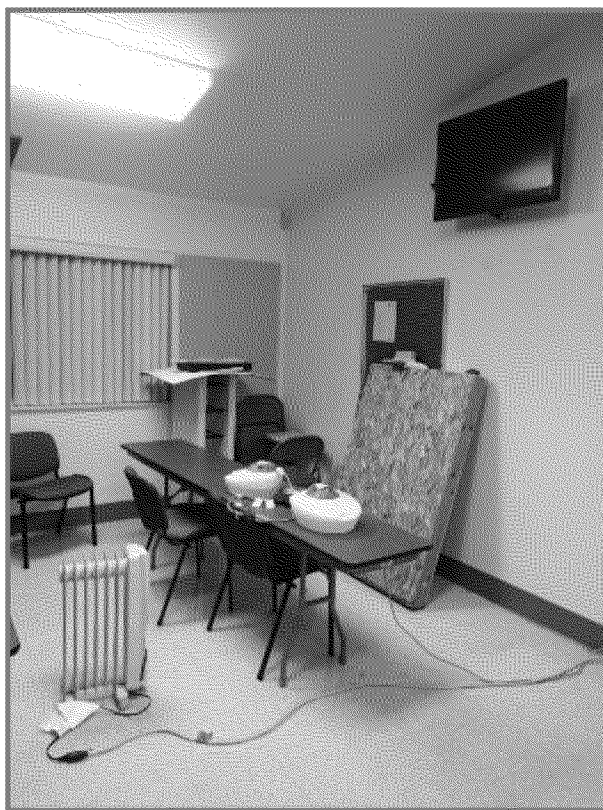
Figure 15. Radiant Heater and Two Steam Vaporizers in the House
(Fans not Shown)

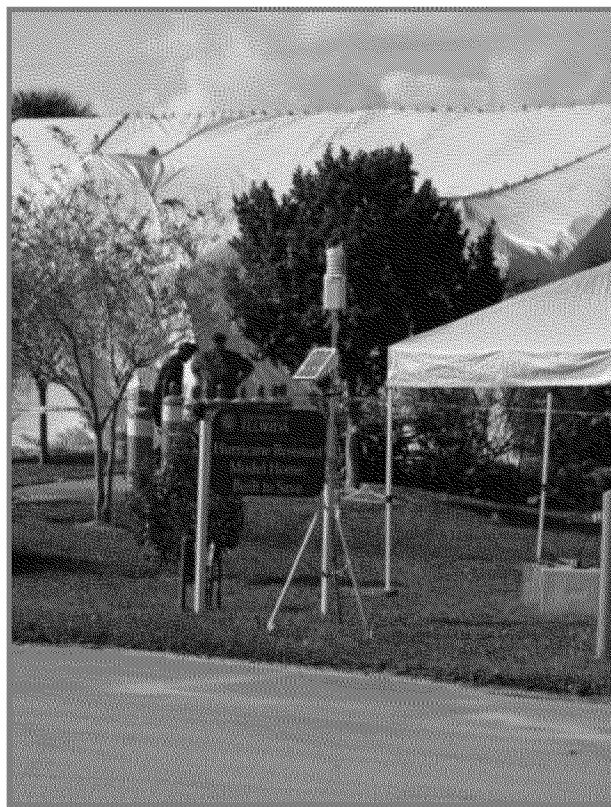
Figure 25. Portable Weatherhawk Weather Station Deployed on Site

Weathering stations used to monitor ambient conditions included the Florida Automated Weather Network (FAWN) and a mobile weather station (Figure 24). FAWN is a group of permanent weather stations positioned around the State of Florida. A permanent station is located on the Fort Lauderdale campus just north east of the house. A 600 Series mobile weather station (Weatherhawk, Logan, UT) was brought by EPA, and positioned just southeast of the house (Figure 25). Data from both units were read via wireless transmission.

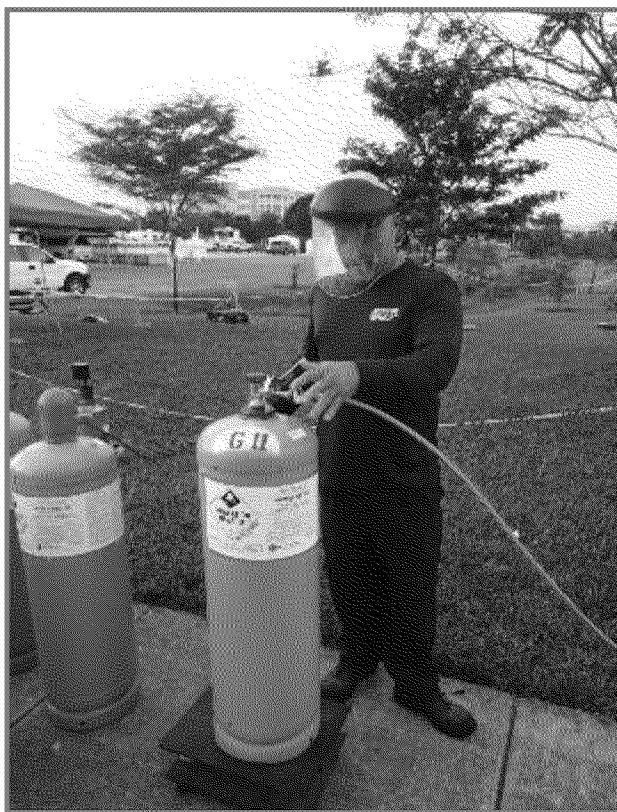
Figure 26. MB Cylinder Being Opened

The MB (100%, Meth-O-Gas 100®, Great Lakes Chemical Co., West Lafayette, IN) was contained as a liquid in commercial 100-lb. metal cylinders (Figure 26). MB without chloropicrin was used to avoid the potential corrosive damage caused by chloropicrin. Since MB has a boiling point of 3.6°C, heat was added during introduction to insure that only gaseous MB was released from the end of the shooting hose. This was done by affixing the cylinder valve, by hose, to a 5-gallon-capacity heat exchanger (Figure 27). The heat exchanger contained a coiled metal tube through which the MB passed. The coil was surrounded by a water/radiator coolant mixture (60:40) which was heated by a propane burner to 90 °C. The gaseous MB exited the heat exchanger through the shooting hose at about 70 °C and then traveled as a gas through the shooting hose and exited into the shooting bucket inside the house. The certified applicator (Hammerhead Termite Control, Big Pine Key, FL) placed the MB cylinder on a balance and donned a full-face shield before he opened the MB cylinder (Figure 26). All MB released was measured gravimetrically.

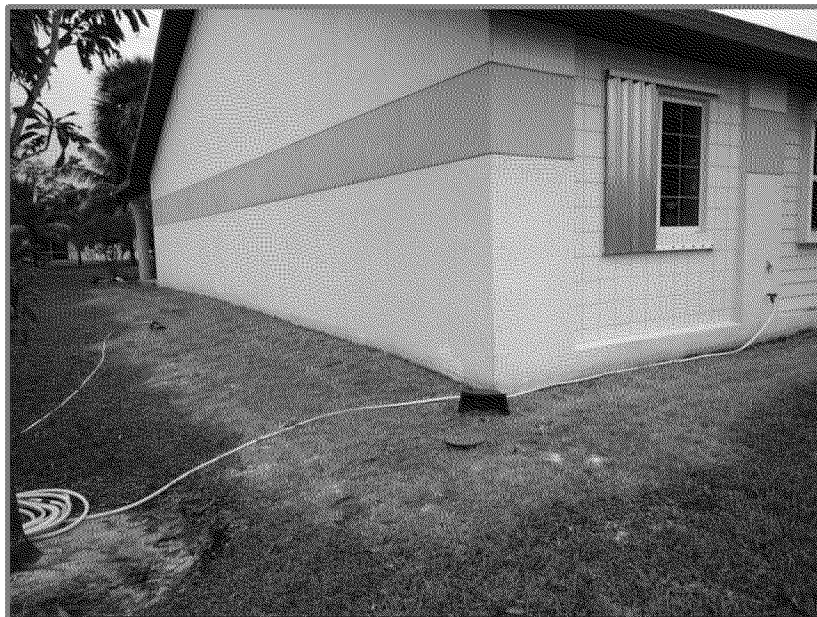
Figure 42. Grass Kill as a Result of MB Diffusion Through the Ground-seal Apron.

- As seen in Figure 42 below, grass kill was the result of constant MB diffusion through the ground-seal apron. Some diffusion plume trails are seen as brown grass extending beyond the ground seal apron. Similar diffusion must have also occurred through the entire raised surface resulting in loss of some 200 lbs of MB. The new aluminum-layered Insul-tarp® planned for a future fumigation should reduce diffusive loss greatly. As noted in the report, the other important loss of MB was related to ducting connections from the house to the scrubbers and increased pressure from adding gas to the enclosure.
